MERRIMACK RIVER BASIN  
BELMONT, NEW HAMPSHIRE

BADGER POND DAM  
N.H. 00085

PHASE I INSPECTION REPORT  
NATIONAL DAM INSPECTION PROGRAM

NOVEMBER 1979

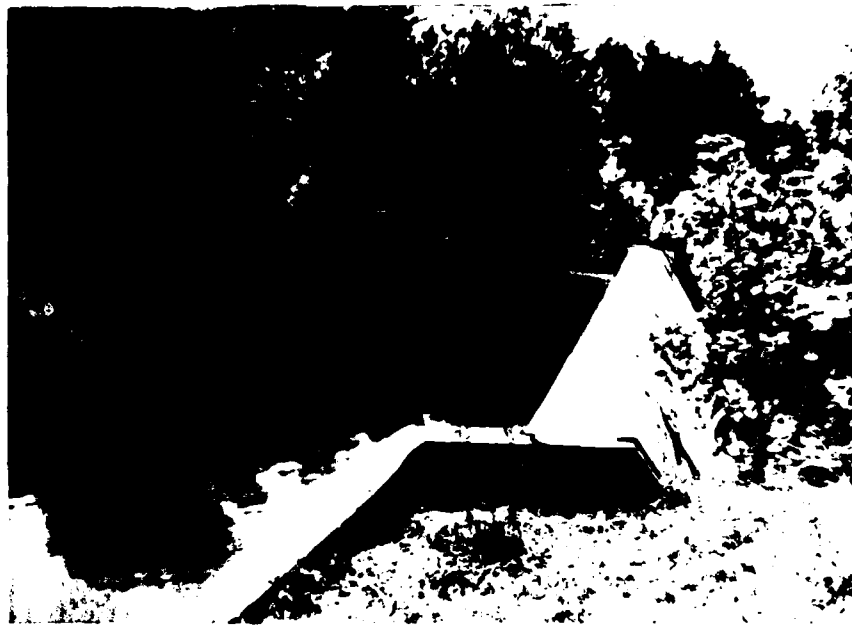
September 7, 1979  
Figure 2 - Looking at upstream face of dam from north abutment.

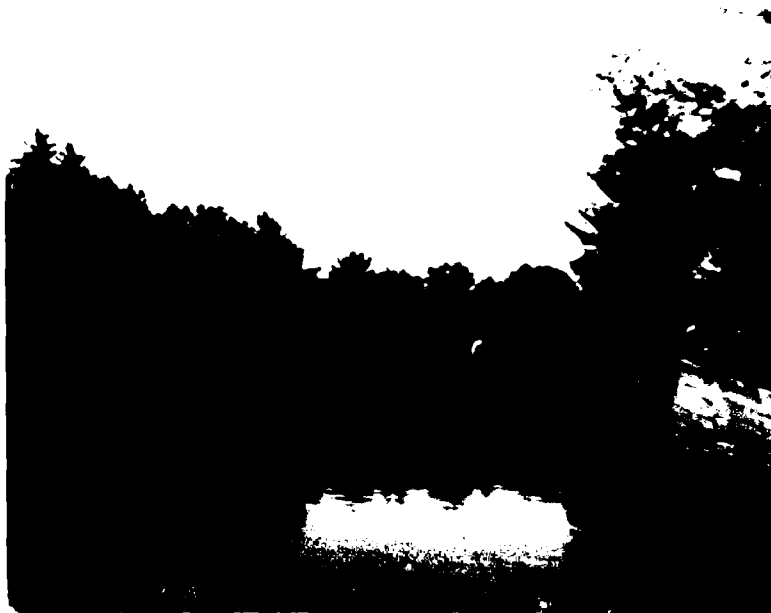
September 7, 1979  
Figure 7 - Looking at vertical upstream face of north abutment.

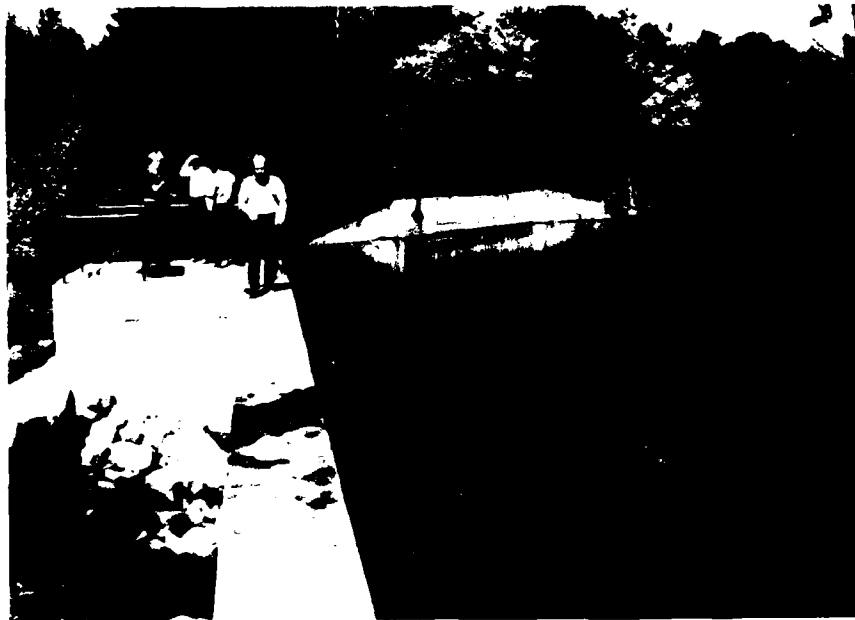
September 7, 1979  
Figure 10 - Looking along crest of south abutment to  
control tower, spillway and north abutment.
